**SEMINOLE COUNTY GOVERNMENT
AGENDA MEMORANDUM**

SUBJECT: Willa Grove Subdivision Wall Contribution

**Re: Review of Failed Privacy Wall
Willa Grove Subdivision
Winter Park, Florida**

**Re: Report Addendum
Review of Failed Privacy Wall
Willa Grove Subdivision
Winter Park, Florida**

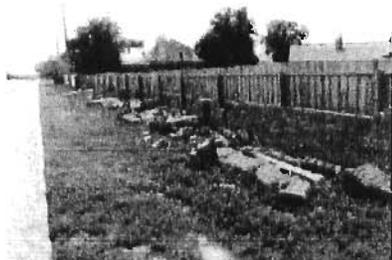
Photo No. 2: Partially collapsed section of wall.

Walter P. Moore and Associates visited the site on August 19, 2005 and August 26, 2005. We observed that a large percentage of the length of wall that faced Tuskawilla Road had collapsed (Photo No. 2). Brick was found laying in the back yards of the various properties along Tuskawilla Road, indicating that the wall had fallen to the west upon failure.

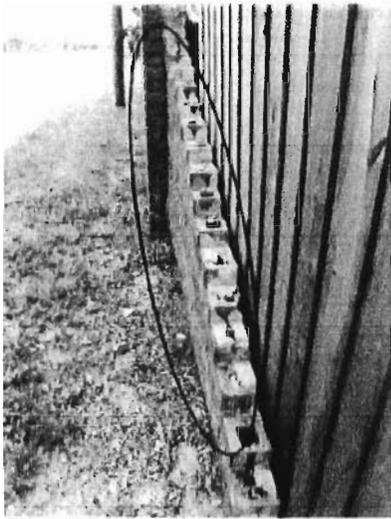
We observed that, with the exception of a section at the south end of the subdivision, the areas of the wall where failure occurred had not been constructed with reinforcing steel (Photo No. 3). Evidence suggests that the wall was built on top of the original sidewalk and that the original sidewalk was constructed with a thickened-edge footing to support the

Photo No. 3: Photograph shows lack of vertical reinforcing steel in failed wall section. wall.

Based on a visual review of the failed wall, it is our opinion that the failures that have occurred are directly related to the lack of reinforcing steel in the wall. Typically, free-standing masonry walls require vertical reinforcing steel to resist tensile stresses that are developed under high lateral load conditions. This is because concrete and brick masonry walls both have low tensile strength and therefore must be reinforced. A preliminary analysis of the wall based on current design codes indicated that the wall does not meet current code requirements for lateral wind resistance. Technical research of the masonry code in effect at the time the wall was constructed can be done as an Additional Service, but it is expected that the allowable flexural tension for brick walls in the earlier code is similar to the value in the current code. Addition of brick masonry units to the top of the original wall would have contributed to the lateral failure of the wall because it would have created more surface area over which wind pressures could develop on the wall. Please note that we were not able to visually confirm where bricks had been added as was stated in correspondence from others.

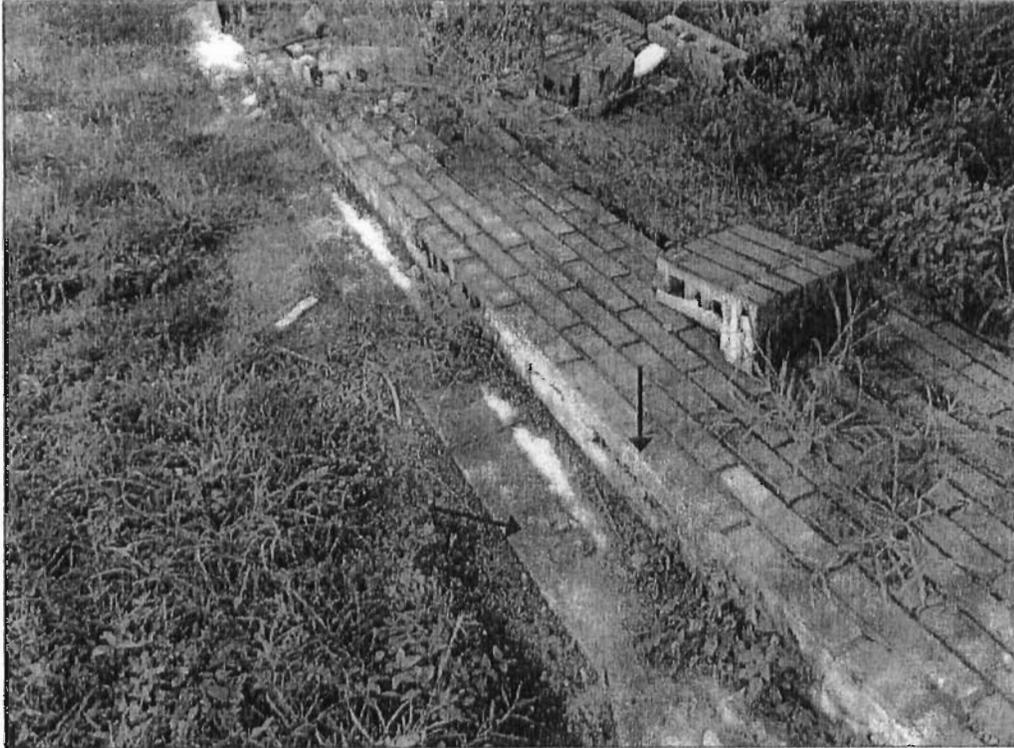
There were two basic failure modes noted during our review. One involved separation of the bottom course of masonry from the concrete foundation (Photo 1). The other involved separation of the wall along one of the horizontal mortar joints located near the base of the wall (Photo 2). Without vertical reinforcing steel, the weight of the wall and the brick-to-brick and brick-to-concrete mortar bond had to resist the entire overturning moment induced in the wall by the wind loading. Failure of the mortar bond led to collapse in both failure modes. There was minimal to no rotation of the footing observed at these locations. This is consistent with the findings at still-standing wall sections that were leaning. Based on level readings, it is estimated that the footings at these sections had rotated less than two and a half degrees. Greater rotation of the footing and wall would be expected if the primary cause of the collapse was an unstable foundation.

Photo 1: Collapsed section of privacy wall where base course of masonry (right arrow) separated from concrete footing (left arrow).

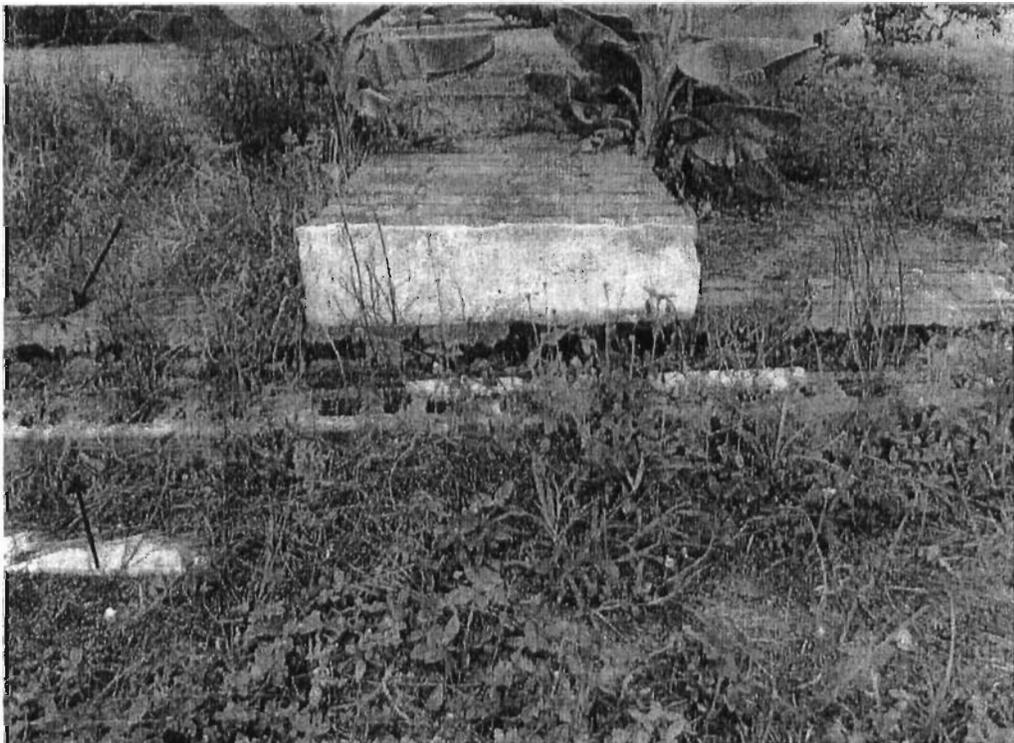
Photo 2: Another collapsed section of the privacy wall. Failure at this location occurred at the horizontal (bed) joint of the first (lower arrow) and second courses of masonry (upper arrow).
