Finding of Necessity for a Community Redevelopment Area

US 17-92 Corridor Seminole County, Florida

May 1997

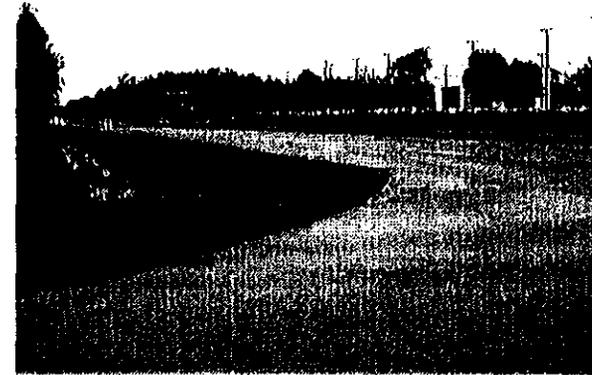
There are examples, albeit limited, of contemporary design standards and practices at work, to include access controls, orderly internal site circulation and well maintained buildings, signage and site landscaping.

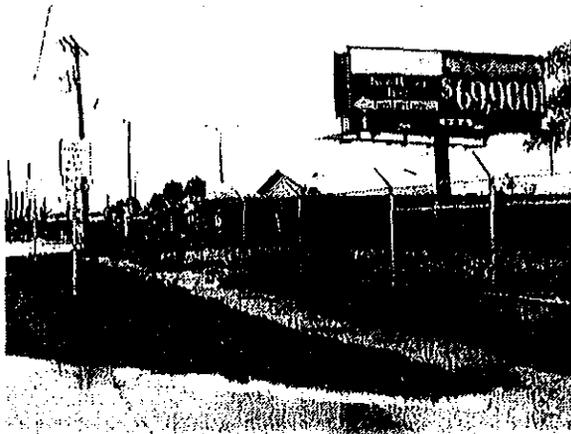
In some cases, the sense of abandonment and dereliction is clearly reinforced by the deliberate steps to "protect" the leftover area.

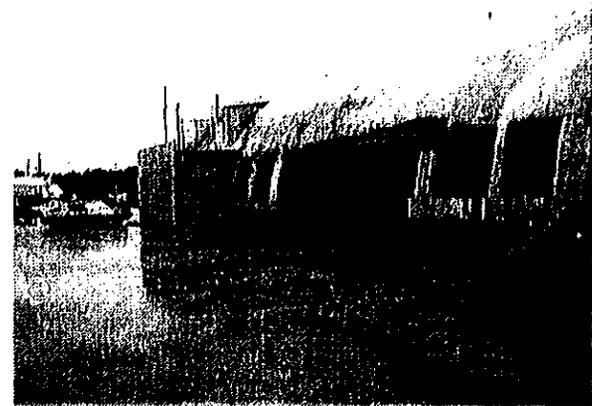
In contrast, examples of the continued demise of older developed sites are perpetuated throughout the corridor.

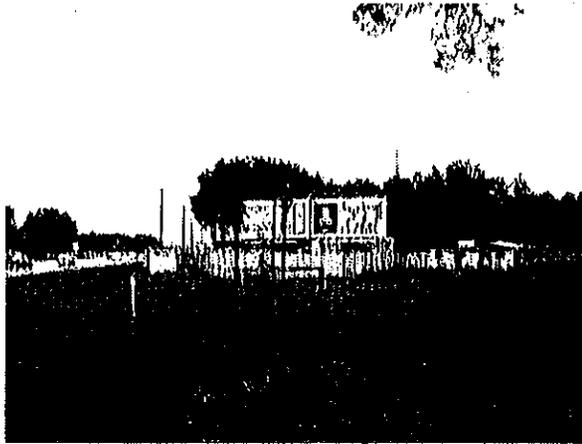
Near the southern end of the corridor, the unmaintained empty lot, the derelict billboard skeleton and the visually challenging auto debris site do not provide an impressive welcome to the County's main shopping street.

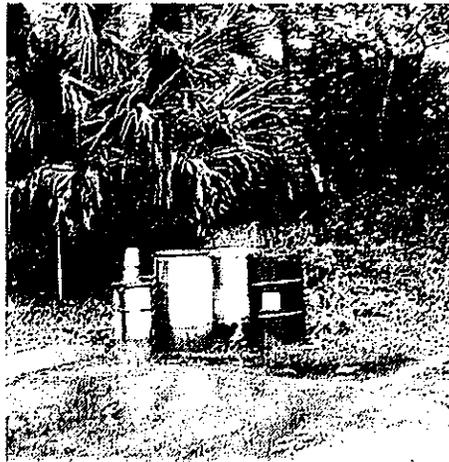
Historically, the preponderance of auto related product facilities and other industrial uses has resulted in documented cases of environmental degradation. The potential for additional problems remains high, as evidenced by these photos taken at a closed and abandoned auto sales and service center.

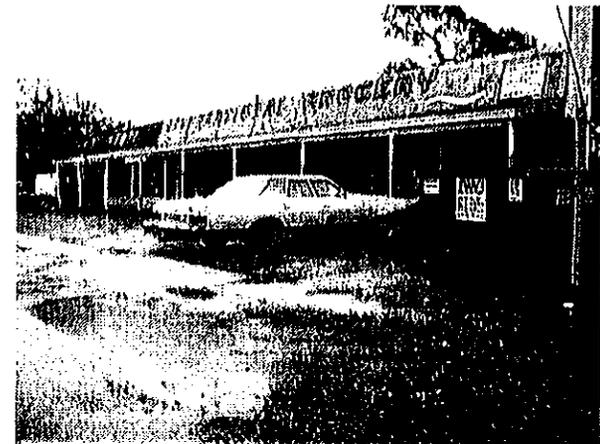
This particular site, just south of a major cross-street intersection, features the strident cartoon color scheme. The majority of the building is abandoned and completely gutted, piles of trash and other furniture debris were found along the roadside parking lot.

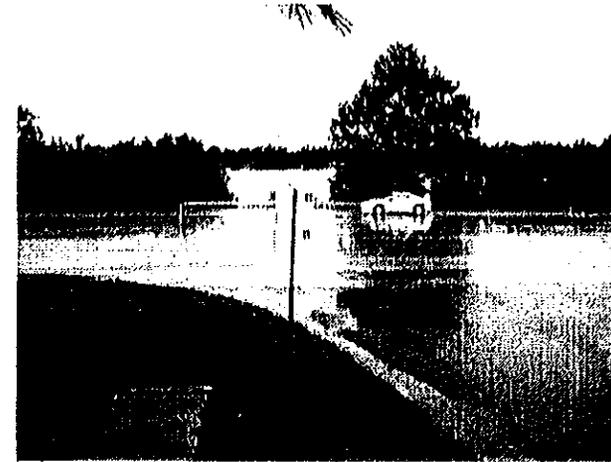
Lakes and other active and passive open spaces are interspersed at several locations along the corridor; rather than serving as positive urban design attributes, they are a largely ignored - and oft times degraded - resource.

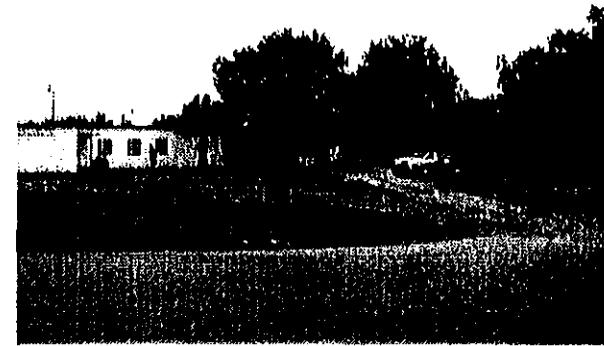
Another example of the combined impact of small lot development patterns and "creative" approaches to solving the site circulation dilemma.

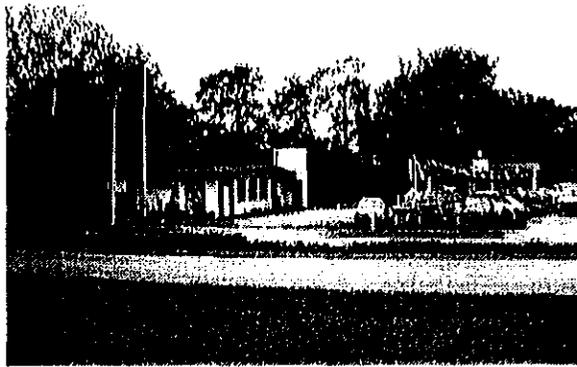
A good example of the small lot development pattern and site discontinuity, a common circumstance that tends to reinforce low intensity site utilization and thwart parcel aggregation and investment in larger scale development efforts.

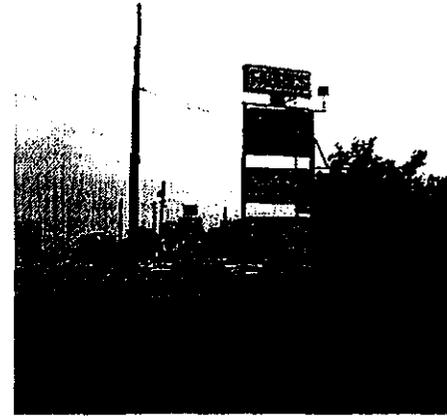
Underscoring the small lot development patterns, this photo offers an interesting corridor example of creative parking methods, omitted site landscaping, a plethora of unrelated signage treatments and disjointed pedestrian amenities.

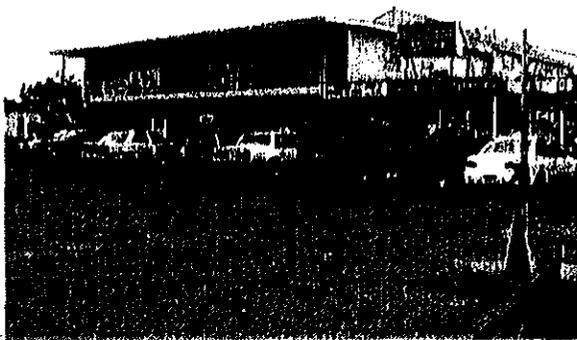
Another example of an anachronistic and undesirable development condition along the corridor.

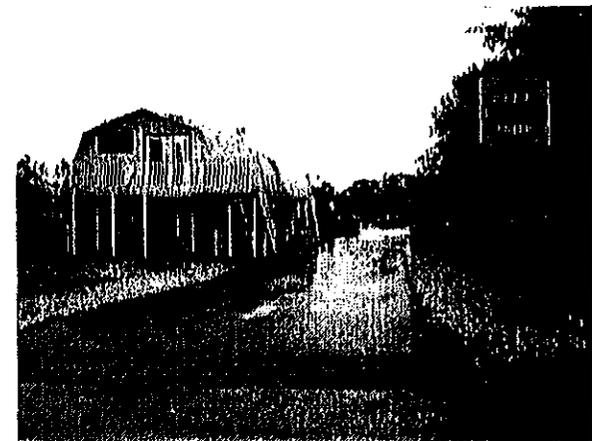
The combination of dated building architecture, small lot vehicle circulation challenges and the lack of contemporary landscaping, parking and stormwater management improvements - a common problem along the corridor - are clearly underscored on this site.

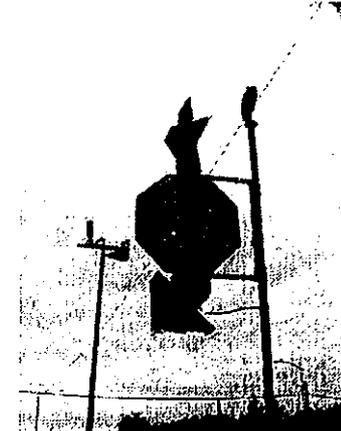
While there may be inherent historic value with some of the corridor signage, dereliction in the maintenance of many signs lends itself to a visually blighted condition.
